FASTFORM Advanced formability test 1/2004

FASTFORM Advanced formability after the fact 3/2004

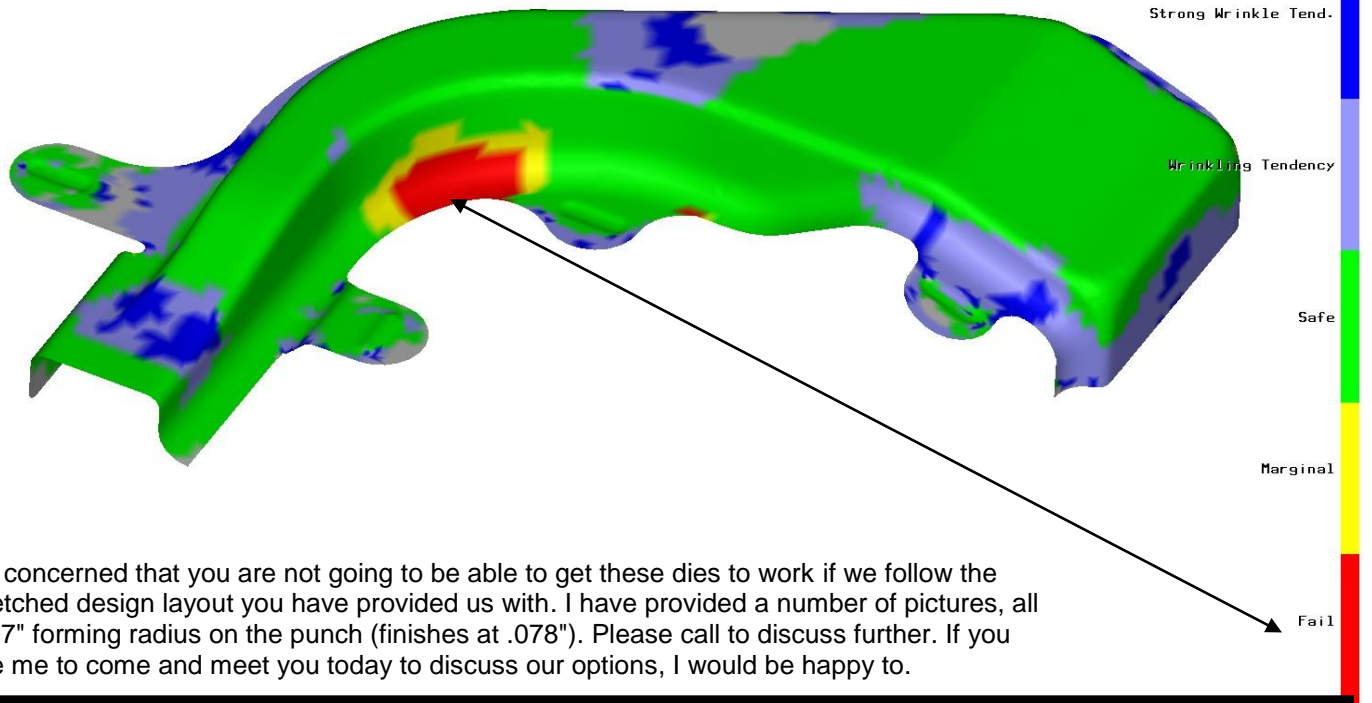
Material Type: HRHSLA60

Material Thickness: 0.0470 in

I am very concerned that you are not going to be able to get these dies to work if we follow the rough sketched design layout you have provided us with. I have provided a number of pictures, all with a .197" forming radius on the punch (finishes at .078"). Please call to discuss further. If you would like me to come and meet you today to discuss our options, I would be happy to.

Above is the FASTFORM Advanced report that we sent to our customer at the preliminary design stage.

As you can see from the pic on page 1 of 2, FASTFORM Advanced was proven to be 100% accurate in predicting that this part would fail, and exactly where it would fail. A solution then needed to be found to keep it from tearing. The obvious thing to try was to add more material since less certainly wasn't an option. We had added an extra station anticipating that some final trimming may need to be done to this part. The obvious question was; how much material needed to be added? Well, in this case, they did it the old fashioned way. Trial and error. In and out of the press. Have more parts cut on the waterjet. Try it again. Several parts were tried but the rip in the inside wall just started moving from one spot to the other as they added material. Of course, they only had eight weeks to design and build these two dies, a right hand and a left hand. The toolmakers building the dies were working 65 hours per week. Finally, they came up with just the right amount of material to add to keep the parts from tearing. But now the trimming stations had to be designed and added to both dies with crunch time fast approaching. While they did a fantastic job in finishing these dies on time, they also learned a valuable lesson:

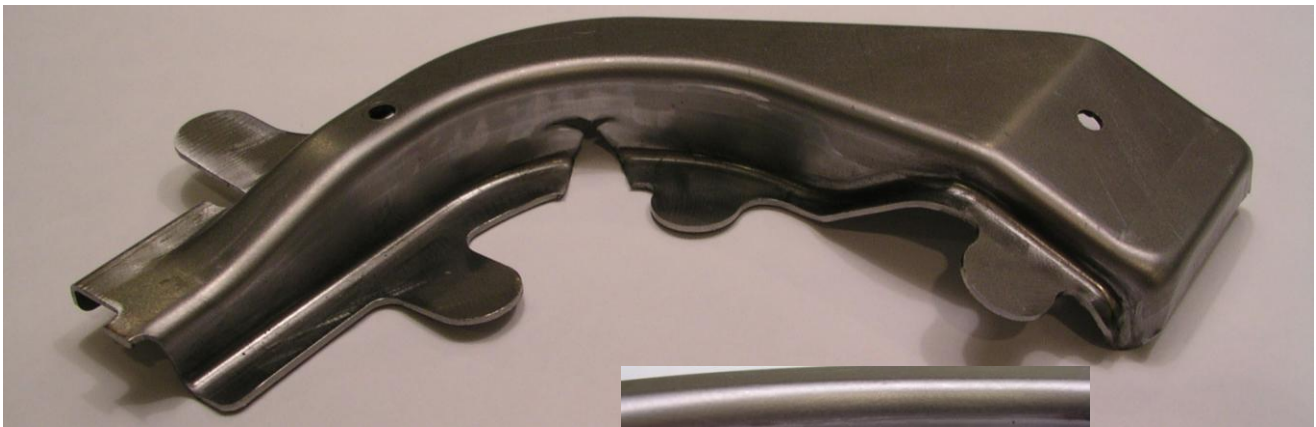
Below are pictures of the actual results from the first hits in development that our customer came up with. Because we knew up front that we could have problems, we added extra idle stations that ultimately got used. Please see the other side for information on how this problem ultimately got solved.

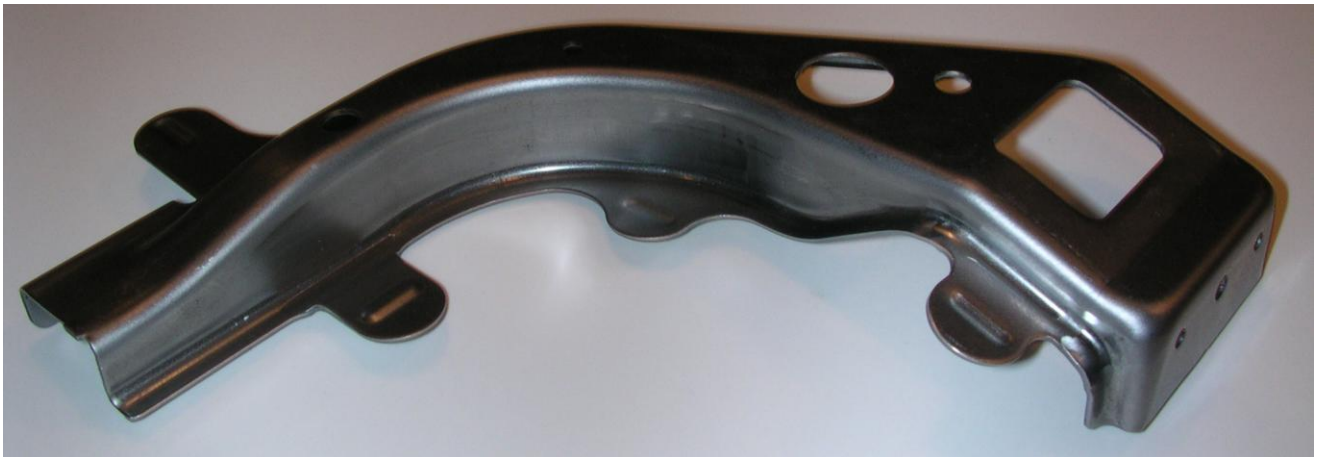
Below is a picture of the finished part off of one of the two dies.
